TEST RESULTS REPORT AND TECHNOLOGY
DEVELOPMENT REPORT, HLH/ATC DRIVE SYSTEM
AFT ROTOR SHAFT BEARING TEST

Boeing Vertol Company

Army Aviation Systems Command

January 1974

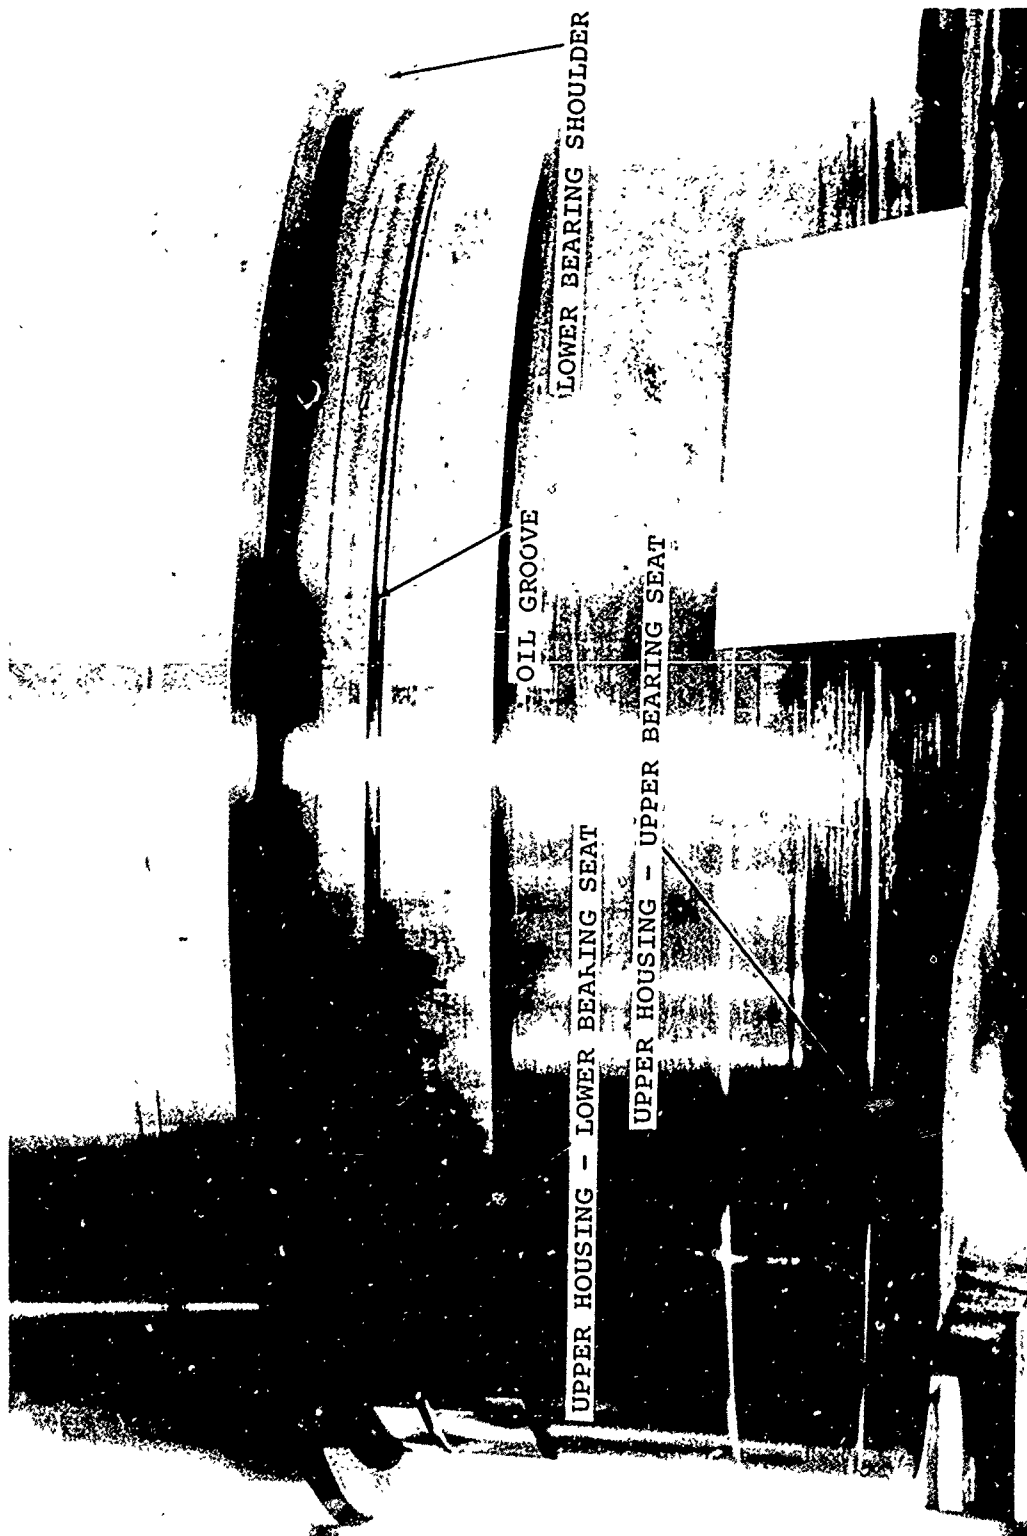
Figure 14. Condition of Shaft of Upper Housing Bearing Assembly.

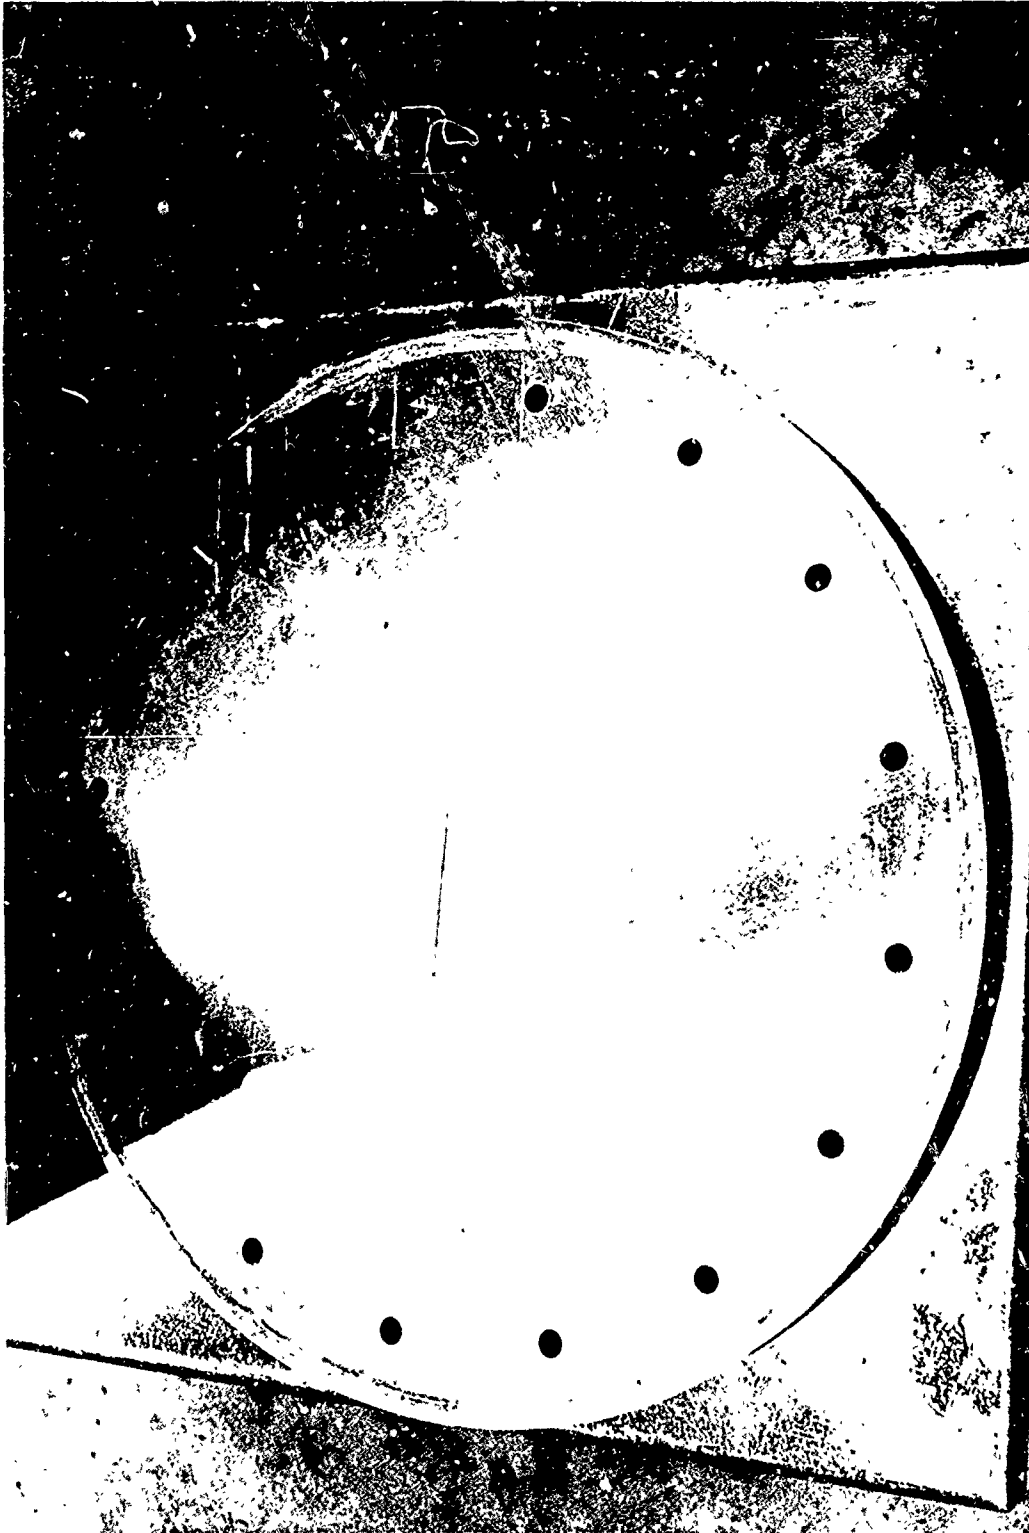
Figure 18. Upper Bearing Assembly Preload Plate Scored due to Bearing Rotation on Shaft.

The damaged bearings from the upper housing assembly were returned to the manufacturer for rework, and the preload plates from the upper and lower housing assemblies were resurfaced to remove the galled areas (Figures 18 and 19).

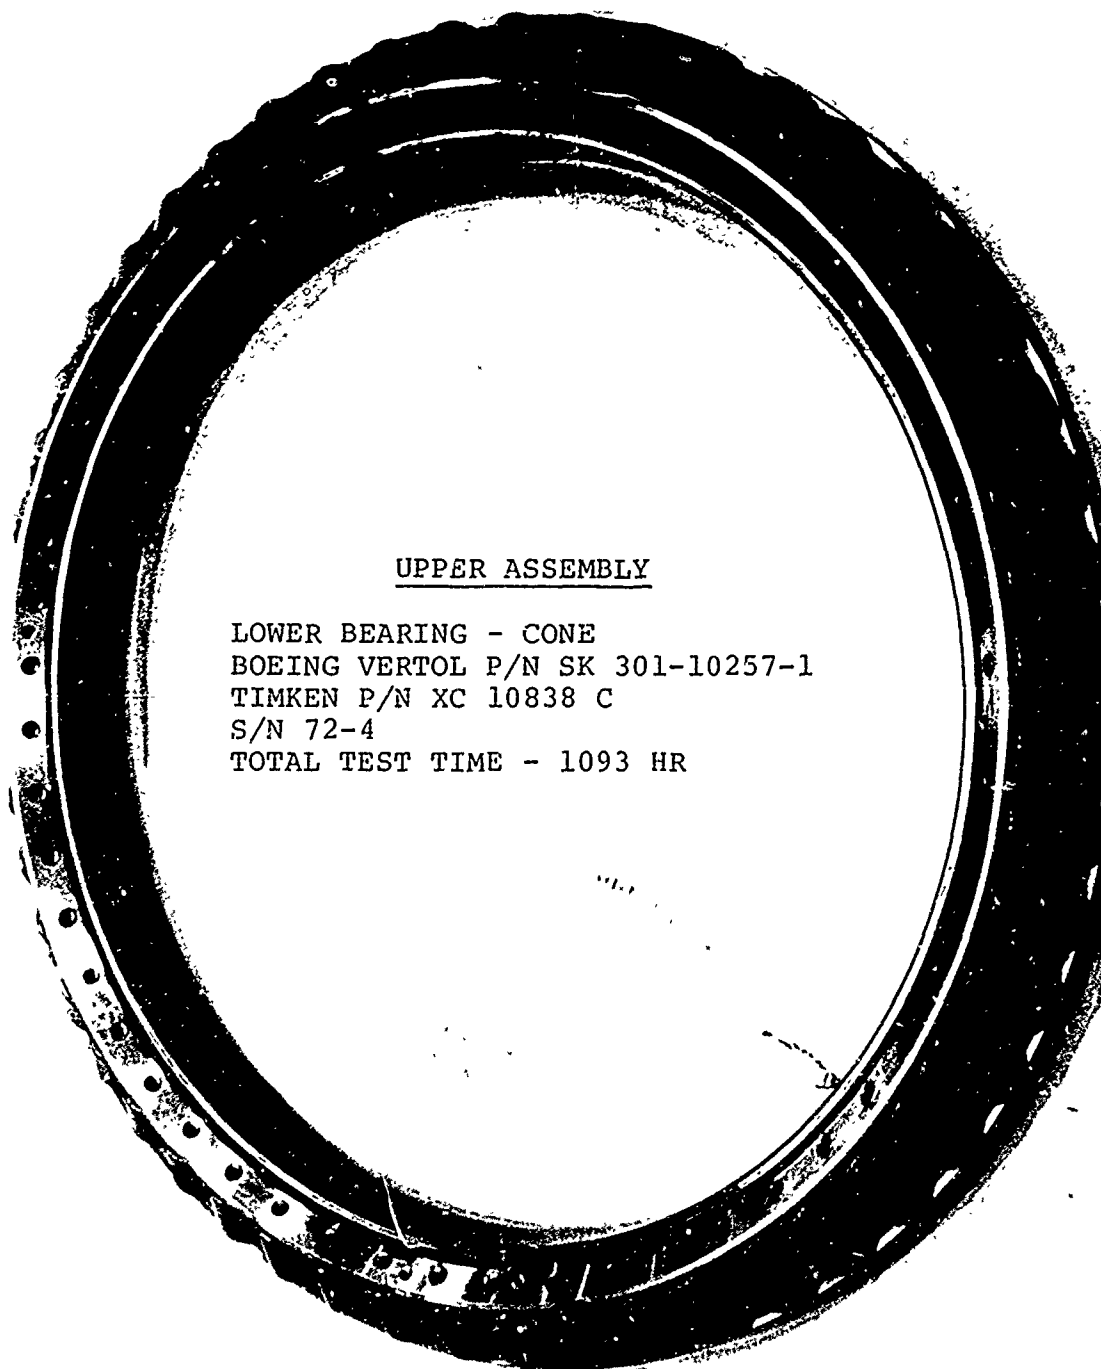
An evaluation of the test hardware after the test suspension revealed that the lower bearing in the upper assembly had failed. Thirty-eight of the rollers had spalled as well as the cup in approximately 6 areas. The cup failed in the area of highest load application (areas R1 in Figure 7) which was also the area of greatest housing stiffness. Figures 21, 22, 23, and 24 show the failed components.

The bearing failure may have been influenced by the shock loads applied as a result of the frequent loss of preload when the preload bolts failed and edge loading of the rollers resulting from a lateral growth of the bearing cone due to radial loading caused by the preload plate deflection. Prior to disassembly, the final end shake and rotational friction torque conditions of the assemblies were determined. These values are shown in Table VII. Although the bearings spun on their shaft seats during the last series of tests, the tungsten-carbide surfaces did not exhibit areas of galling or fretting. The shaft had a highly polished area on the seat of the upper bearing in the upper housing assembly. Figures 25, 26, and 27 show the bearing seats after testing. It also appeared that the copper plating had a beneficial effect in that the bearing cones in the lower housing assembly had not been scored due to rotation on their shaft seats.

Figure 21. Failed SK301-10257-1 Cone Assembly.

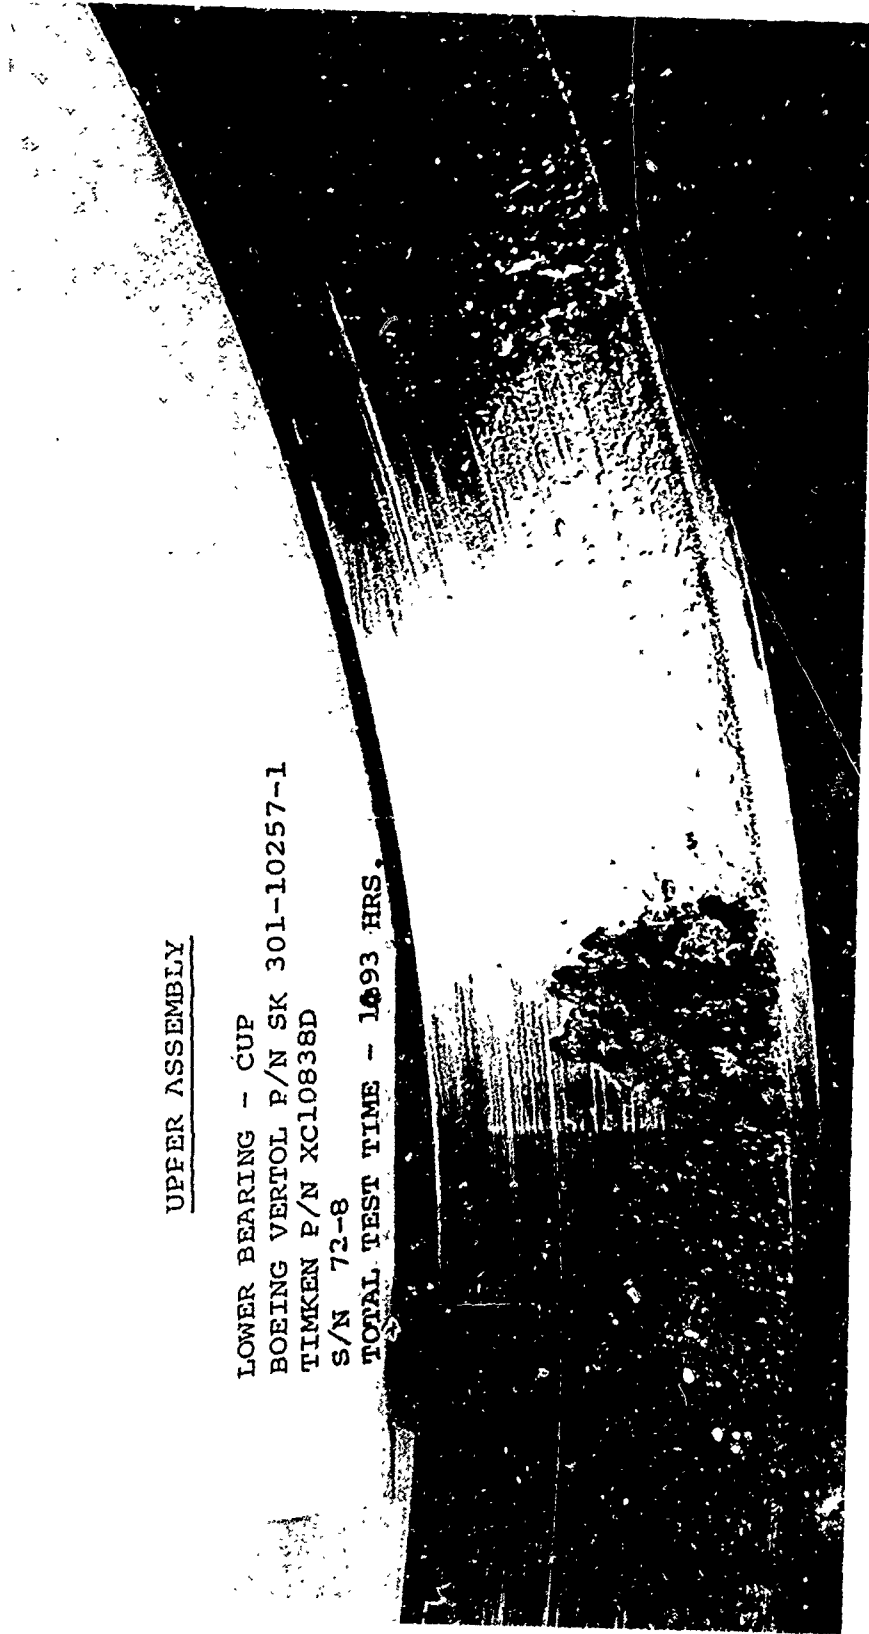
LOWER BEARING - CUP
BOEING VERTOL P/N SK 301-10257-1
TIMKEN P/N XC10838D
S/N 72-8
TOTAL TEST TIME - 1093 HRS.

Figure 23. Spalled Cup of SK301-10257-1 Bearing.

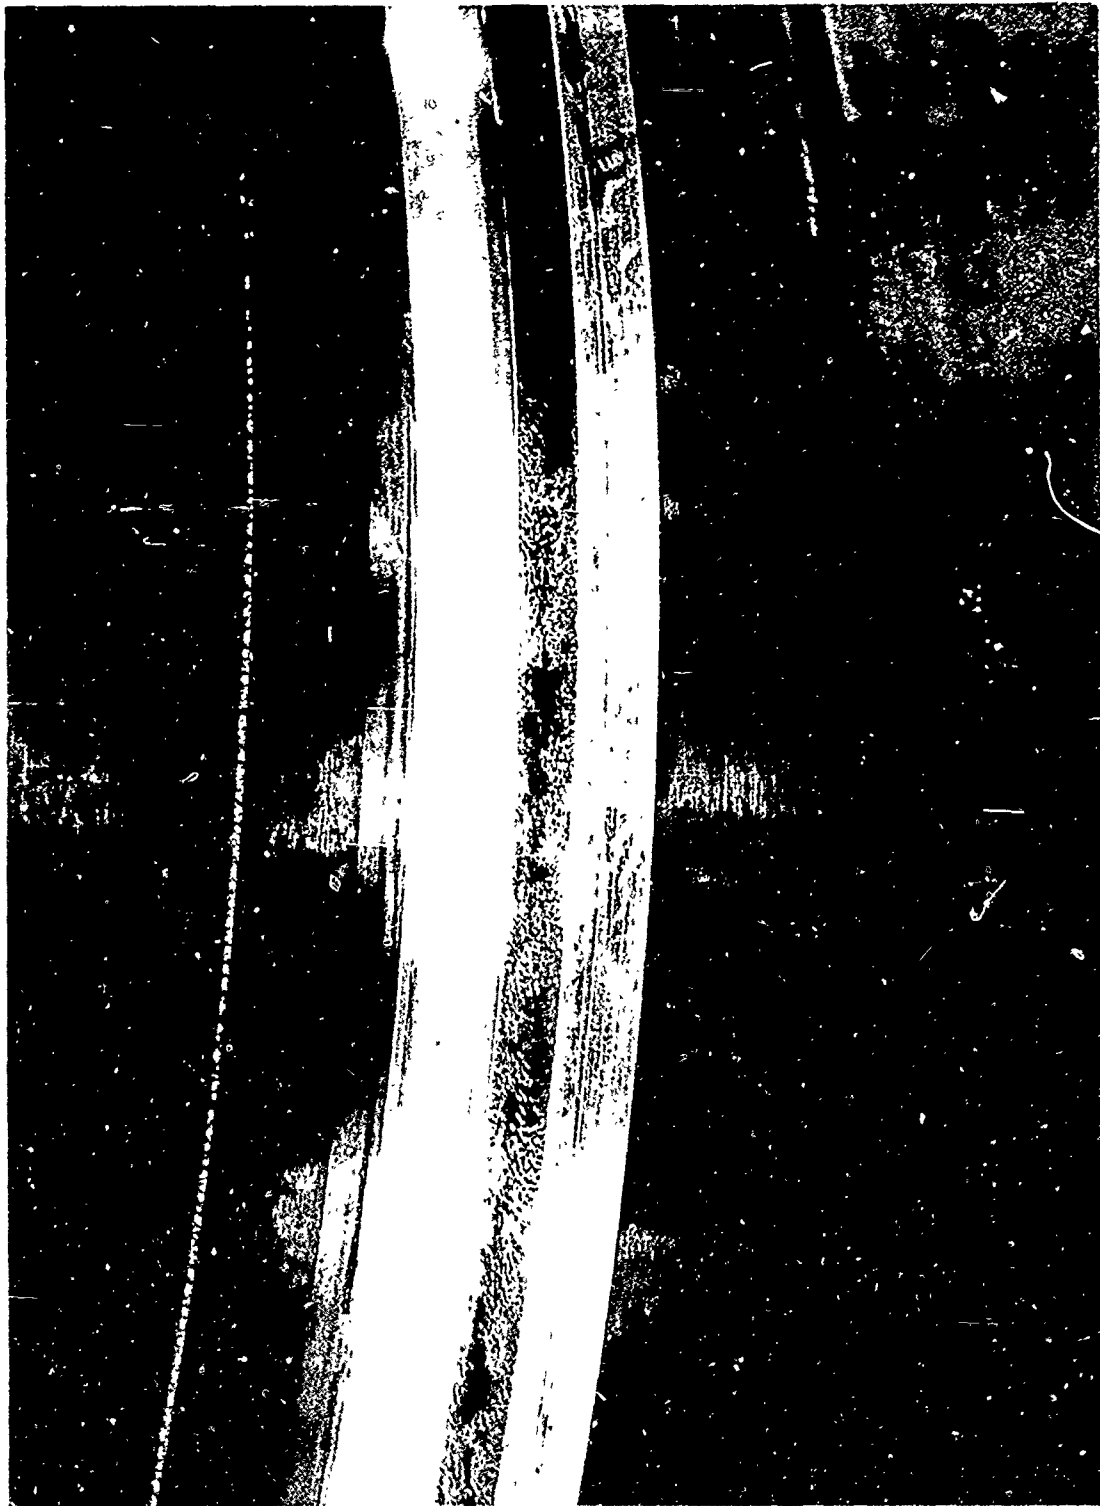
It was noted that the assembly and disassembly of the test specimens on the bearing seats were much easier with the tungsten-carbide seats than with either the original surfaces (9310 steel Rc 34-38) or the stainless steel surfaces. This was attributed to two factors: first, experience gained in the assembly process and second, the increased hardness of the tungsten-carbide surface and the superior surface finish; i.e., 8-12 inches rms with the tungsten carbide as opposed to 32 inches rms with the 9310 steel and 440C stainless steel surfaces. The initial conditions of the test assembly before starting the second test run are given in Table VII.

Figure 26. Tungsten-Carbide Bearing Seat - Upper Housing, Upper Bearing.

After removing the stainless steel bearing seats, the seats were rebuilt by Union Carbide with a tungsten carbide (Union Carbide designation LW-1N40) surface (Rc-72) using a detonation spray process. The seats were precision-ground to final size with a diamond abrasive wheel.

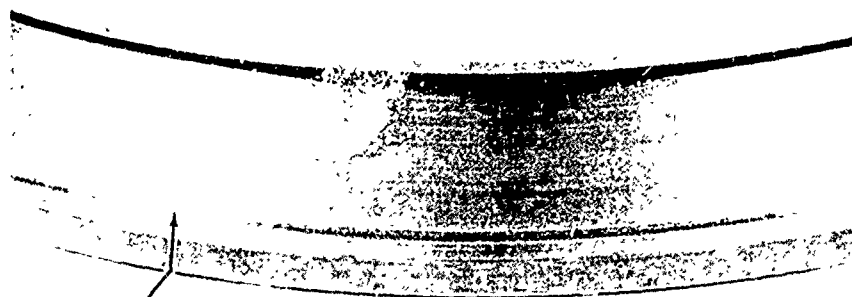
Figure 28. Condition of Cone Raceway of SK301-10257-1 Bearing.

NOTE ETCH MARKS ON RACE & RIB

NOTE GEOMETRIC STRESS CONCENTRATION SPALL
AND DEBRIS BRUISING DAMAGE

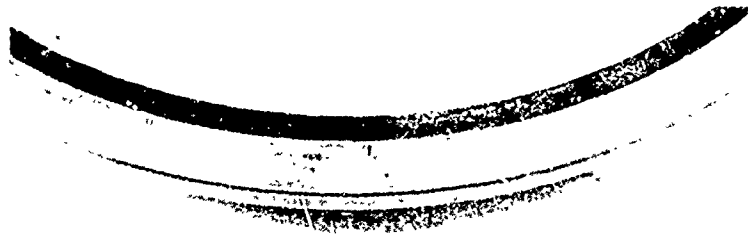
Figure 29. Bore and Back Face of SK301-10257-1 Bearing.

A visual inspection of the cones, rollers, and cage of bearing S/N 72-2 showed evidence of etch staining due to leakage of copper plate solution during plating of the bore and back-face area. Similar etching from the copper plating solution was also observed on the cup surface of S/N 72-8. This type of damage would not have occurred if the bearing bore, outer diameter, and back-face surfaces were plated prior to final assembly of the bearing. A review of the copper-plated and non-copper-plated surfaces showed that the copper plate did minimize the fretting of the surfaces.

BACK FACE - FRETTED AT SUPPORT;
SCORED AT OUTSIDE EDGE

CONE BORE FRETTING CORROSION

BACK FACE HEAVILY WORN AT SUPPORT AREA

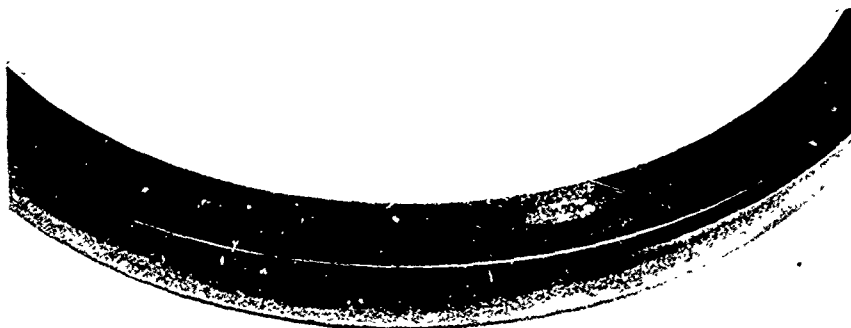
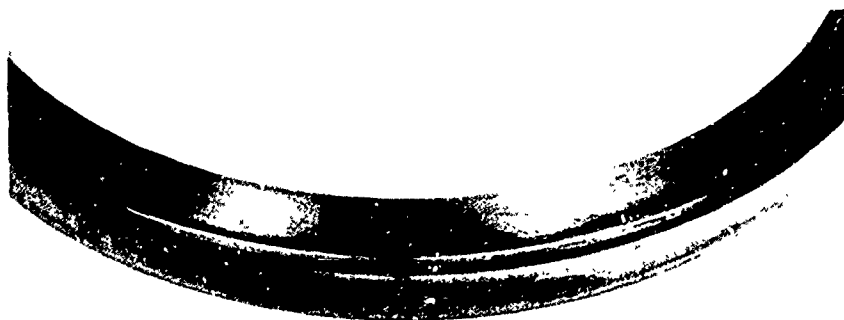
Figure 31. Outer Diameter of Cups of SK301-10257-1 Bearings.

SLIGHT FRETTING CORROSION ON
O.D. (NO COPPER PLATING)

NO SIGNIFICANT FRETTING (COPPER PLATING)
